West Boggs Lake Watershed Diagnostic Study

Prepared by

Jerry Sweeten, Ph.D., Herb Manifold, MS and Kyle Boone, MS Ecosystems Connections Institute 9130 North 600 East Denver, Indiana 46926 Email: jesweeten@ecosystemsconnections.com Phone: 260.901.0561

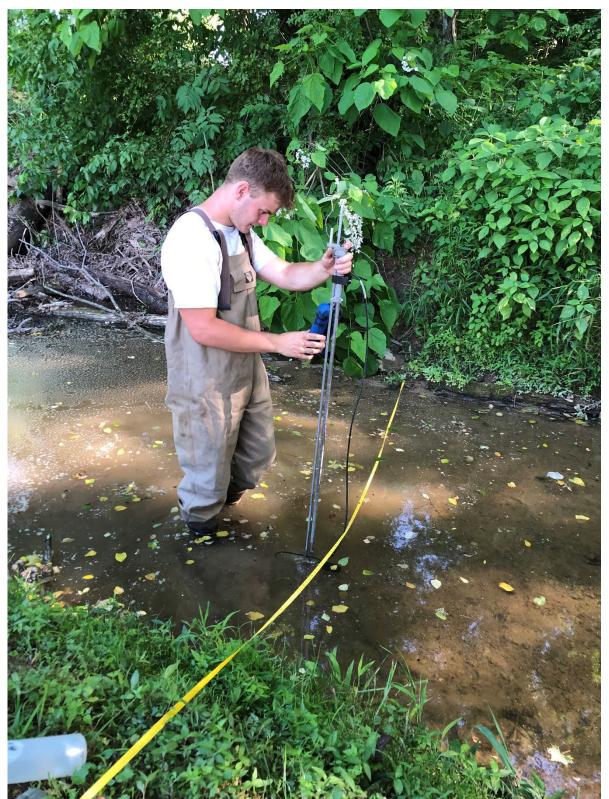
Figure 11. An Ecosystems Connections Institute intern taking a stream discharge measurement at a tributary of West Boggs Lake on 14 June 2021.

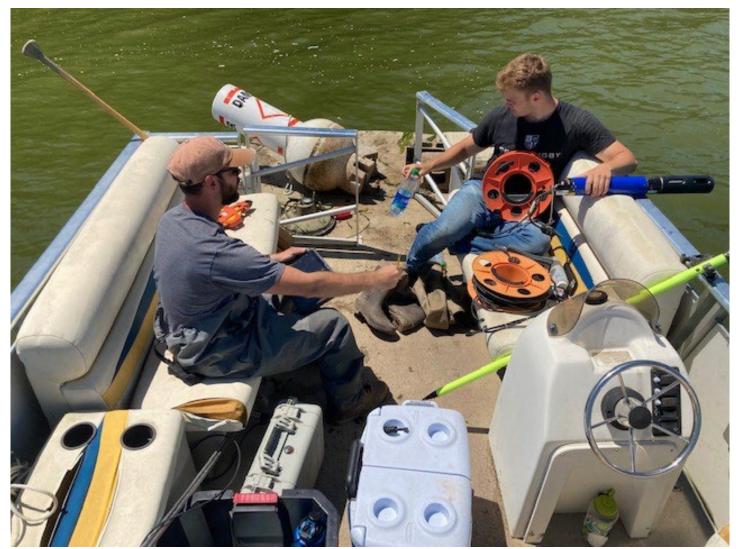
Figure 12. An Ecosystems Connections Institute employee and intern preparing a sonde to utilize for the creation of lake profiles 14 July 2022.

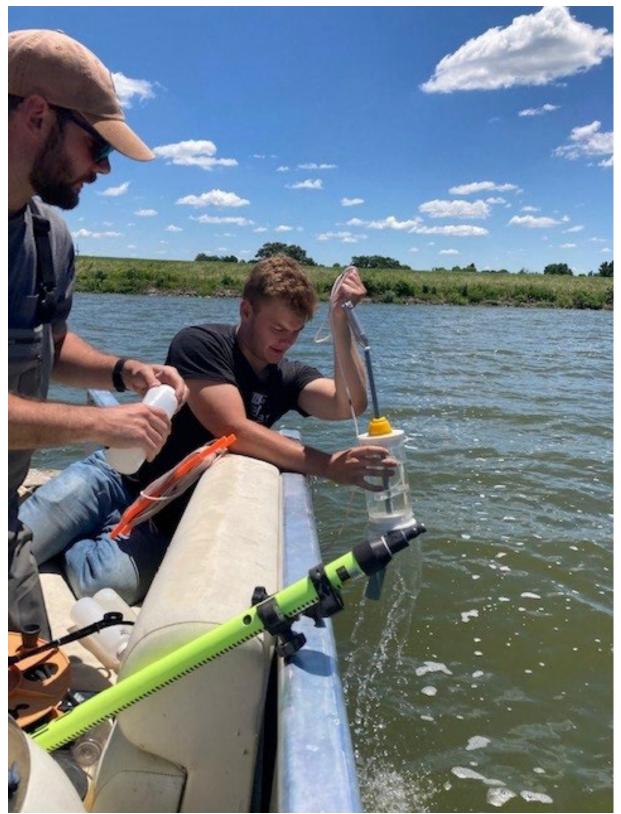
Figure 13. Water sample collection from West Boggs Lake using a Kemmerer bottle on 14 July 2021.

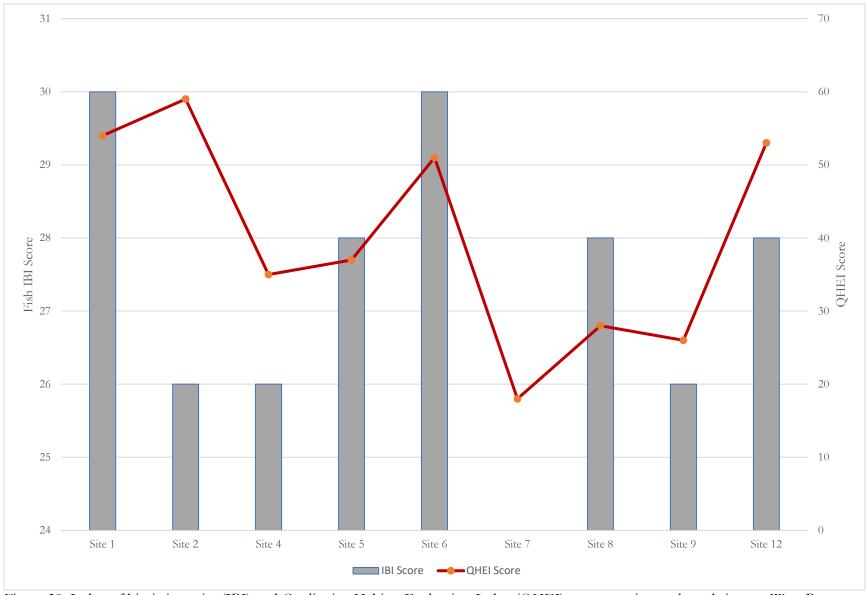
Figure 39. Index of biotic integrity (IBI) and Qualitative Habitat Evaluation Index (QHEI) scores at nine evaluated sites on West Boggs Lake tributaries. No fish were sampled at Site 7

A total of nine sites were evaluated for fish community assessment and stream habitat. Three sites (Site 3, Site 10, Site 11) were not able to be accessed due to low water conditions and logistical restraints. Resulting IBI scores from fish sampling at eight evaluated sites ranked as "Poor". No fish were found at Site 7, therefore an IBI score could not be calculated. Scores ranged from a low of 26 and a high of 30 (Figure 39). Habitat scores were more variable than IBI scores. QHEI scores ranked from "Very Poor" to "Good." Scores ranged from a low of 18 to a high of 59 (Figure 39).

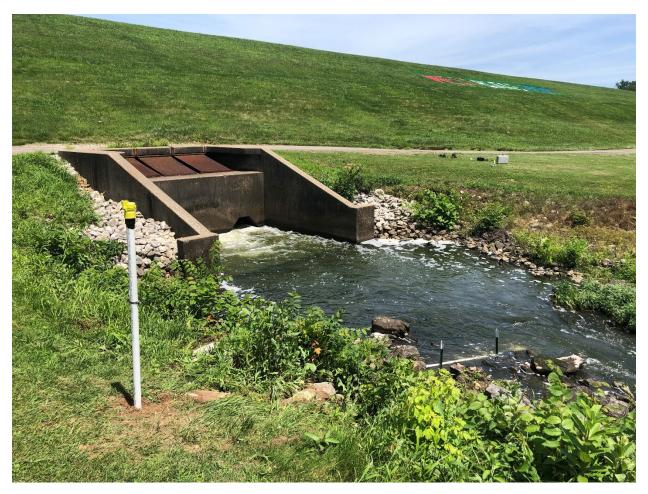
Figure 40. The pressure transducer at West Boggs Lake Outflow. The pressure transducer was used to measured discharge or the amount of water leaving the lake. Once discharge is measured a water budget for a lake can be created.

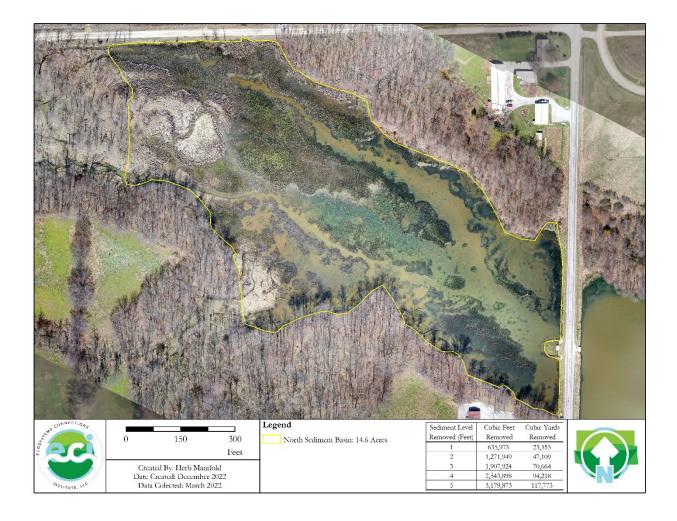
Figure 42. North Sediment basin of West Boggs Lake with calculated cubic feet and cubic yards of sediment by one foot in increments from one to five feet. This sediment basin has an area of 14.6-Acres.
